# SEDIMENT REDUCTION

LAKE HARMONY, POCONOS, PA

Biotechnology solves lake's sediment build up problems.

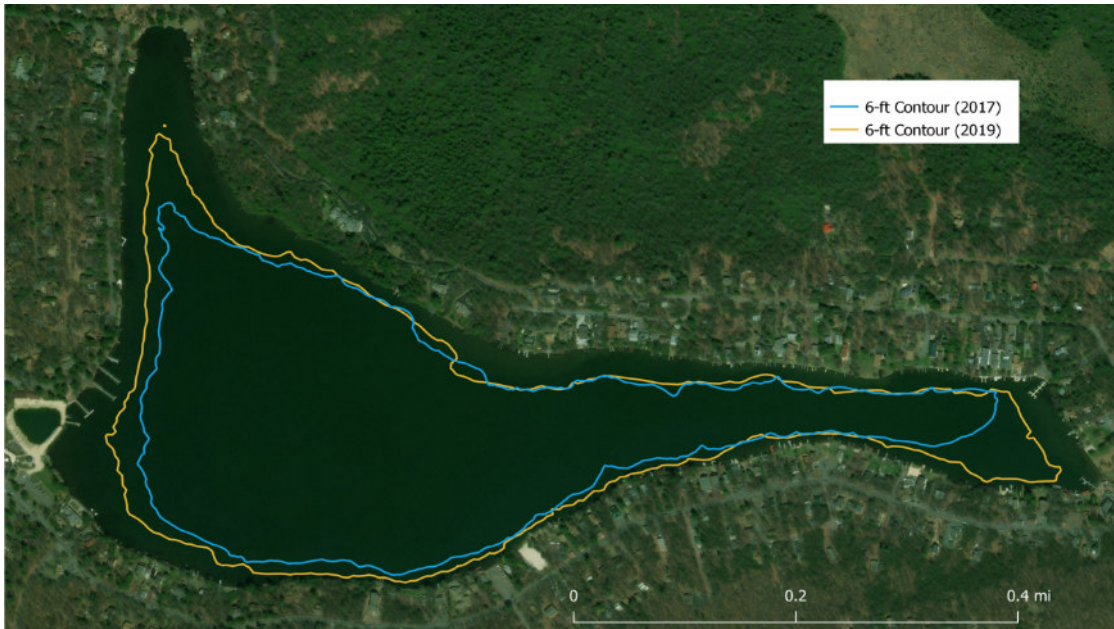
In the picture below, the 6 feet contour has been highlighted

- blue as it was in October 2017
- yellow as it was in October 2019

The area 6 feet deep or more has increased by 12.78 acres.
